Proposed Professional Facility Conditions Study for

PORT WASHINGTON PUBLIC LIBRARY

Facility Conditions Report

As an update to the previous Facility Evaluation Report prepared by H2M architects + engineers in 2017, our team conducted a visual survey of the Port Washington Public Library building on May 1, 2024 to assess its general conditions, determine where deficiencies existing, outline repair recommendations, and estimate the probable cost for each repair and its priority. Attachment 1 includes paired photos showing the damage and recommended repairs discussed in this report. It is recommended that all repairs described in this attachment should be detailed and designed by a NYS registered professional architect and/or engineer.

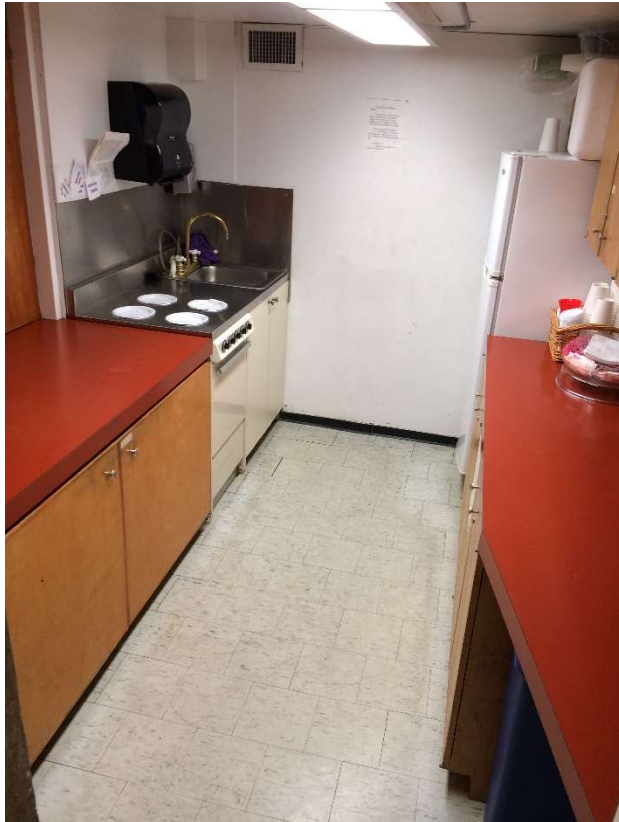
A01 – Pantry flooring below Stage in Auditorium

The 9" x 9" floor tiles in the existing Pantry area below the stage at the Auditorium, the vestibule east of the stage, and the Projection Booth above the existing Pantry are suspected to be asbestos containing materials (ACM) (photo A01). Some of the floor tiles at the stage vestibule are also cracked and loose (photo A02).

We recommend these to be sampled and tested by a certified asbestos investigator and, if found to contain asbestos, be properly abated and replaced.

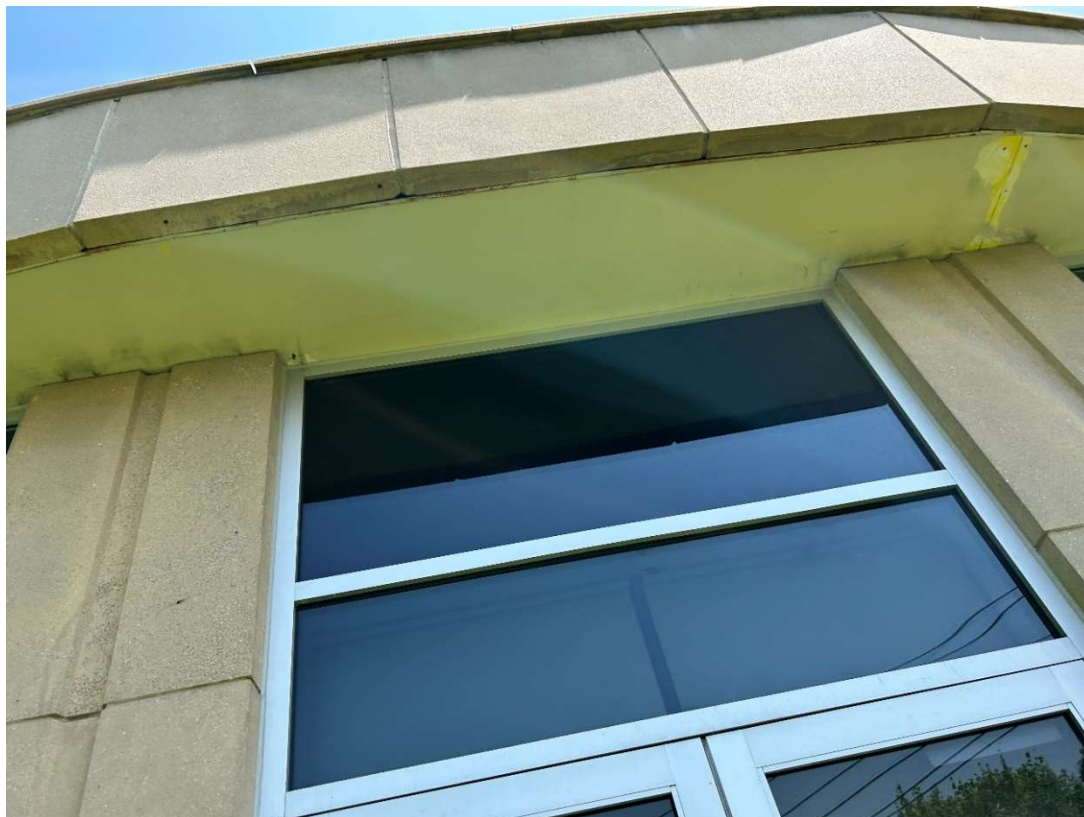
A47 – Terrace Paver Leakage

We observed penetrations at the roof pavers that may be the cause of water infiltration of the building and damage to the façade / soffit (photos A46 & A47). It is recommended to fill the penetration with injected epoxy to remediate the penetration.

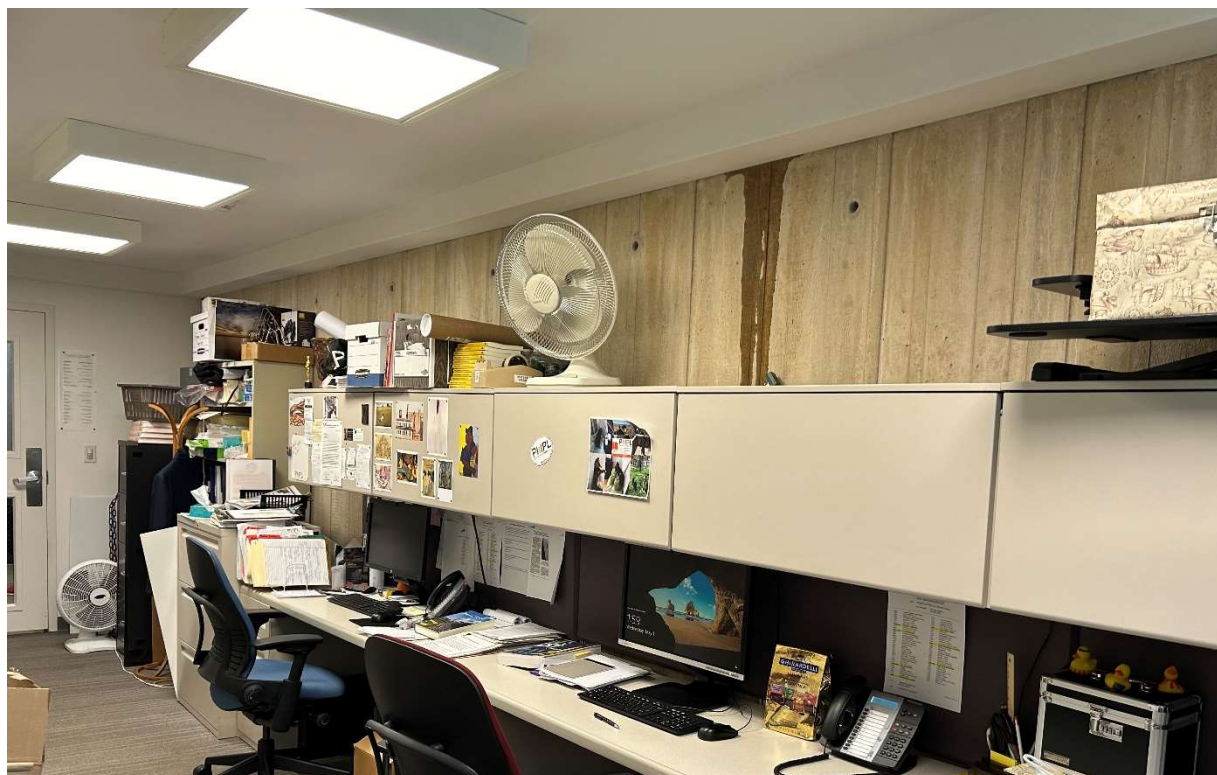
A51 – Leak in Programming Office

The staff in the Programming Office reported a leak on the wall and from the ductwork above the ceiling (photos A51 – A52). It was also observed that their office lacks air circulation as only a 12" x 8" diffuser serves the 3-person office (photo A49).

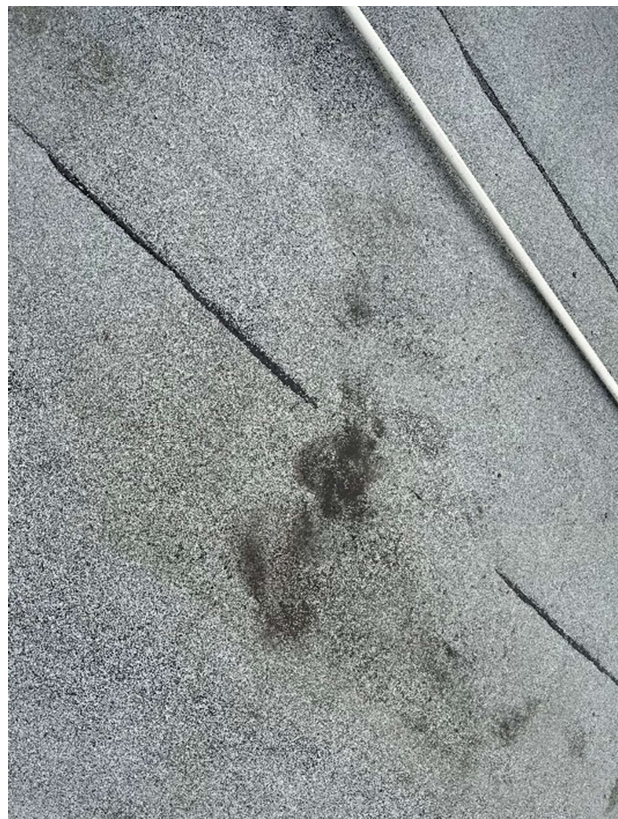
A53 – Roof Membrane

The roofing on the main building was observed to have passed its useful life. The membrane is spongy and soft underfoot, indicating that moisture was trapped between the membrane and the insulation board underneath (photo A53). Seam separation between the membrane was observed (photo A54), most like due to temperature fluctuations and exposure to UV rays, which could lead to water seepage and compromise the effectiveness of the entire roofing system. Some of the membrane has severe deterioration (photo A55) that may have resulted in water infiltration and potential damage to the underlying structure (refer to "Structural – Building Interior" section). It is our strong recommendation that the existing roofing and insulation to be replaced in the near future, with proper insulation pitches to the roof drain. Refer to the Structural – Building Interior section of this report for roof slab investigation.

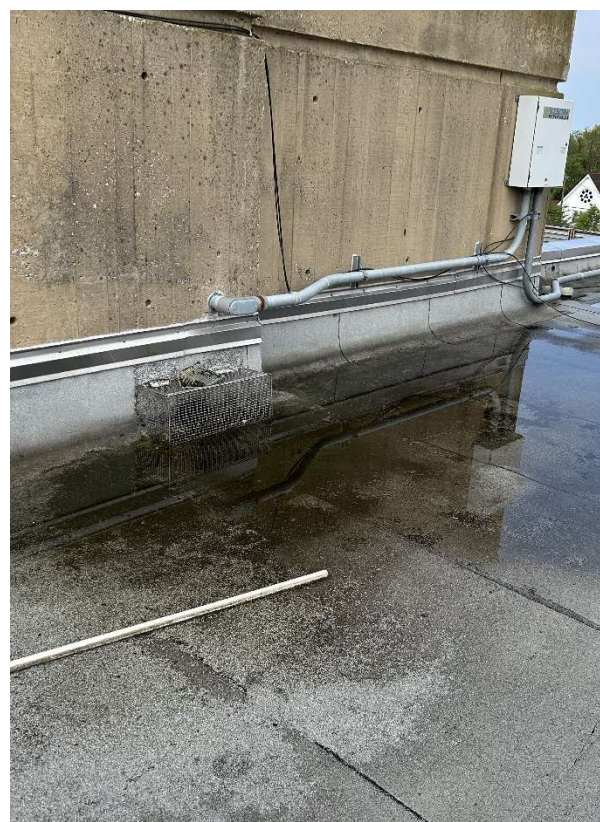
A56 – Ponding at Roof Drain

We observed significant ponding of stormwater near most of the roof drains, particularly on the main roof where the existing skylights are located (photos A56 & A57). It appears that there are only (2) roof drains that handle the stormwater on the entire main roof, which is roughly 6,600 sq. ft. In addition, the taller roofs from the south and north towers are discharging stormwater onto the main roof, increasing the burden on the (2) roof drains (photo A58). Ponding adjacent to roof drains indicates that the drainage pipe could no longer effectively handle the amount of stormwater (photo A60). It is recommended to snake the pipes to investigate if they are simply clogged; further calculations of the roof drainage capacity based on rainfall rate should be performed by a NYS licensed plumbing engineer to verify if additional roof drains are required.

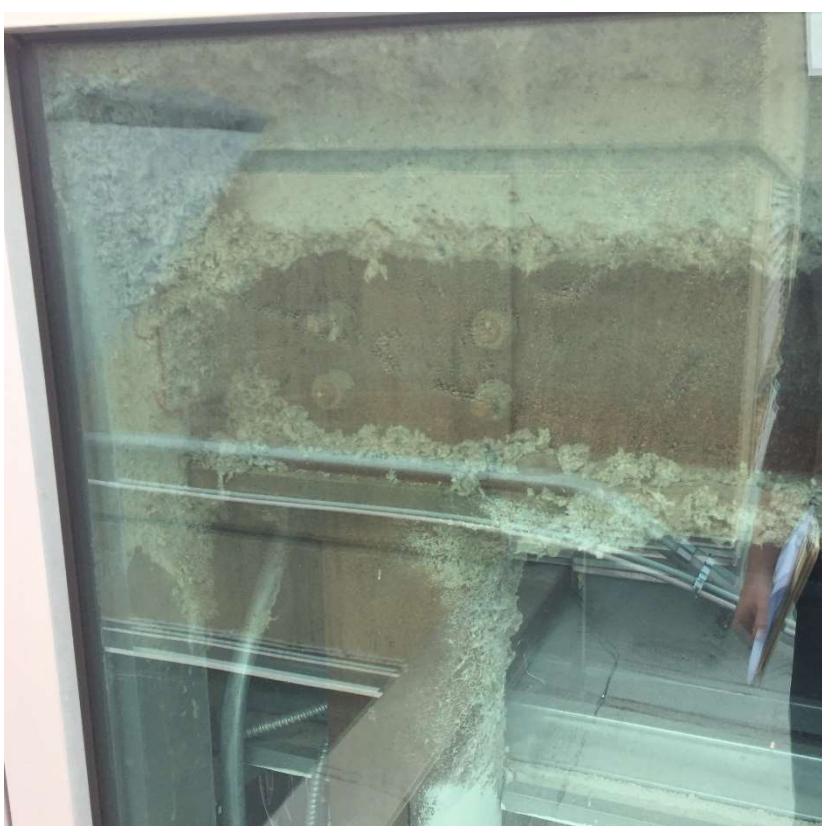
A68 – Fireproofing Deterioration

From the main roof looking into the steel roof framing of the Adult Learning Center through its clerestory windows, we observed that the existing sprayed fireproofing had deteriorated and no longer offers fire protection (photo A68). In reviewing the construction documents prepared by Donald & Liisa Sclare Architects dated 3/1/1999, fireproofing was not shown on the building section of the Adult Learning Center; however, section 07253 of the project manual dated 10/8/1999 for the project included spray fireproofing. It is recommended to perform a code review of the building and determine if fireproofing is required by code, and restore the fireproofing to provide coverage if needed.
